MOTION NO: AGM/2025/03

TO CARRY OUT COMPREHENSIVE RE-TILING AND GROUTING REPAIRS AND ASSOCIATED WORKS AT POOLSIDE OF THE MAIN SWIMMING POOL AND THE WADING POOL UP TO A COST OF RM200,000

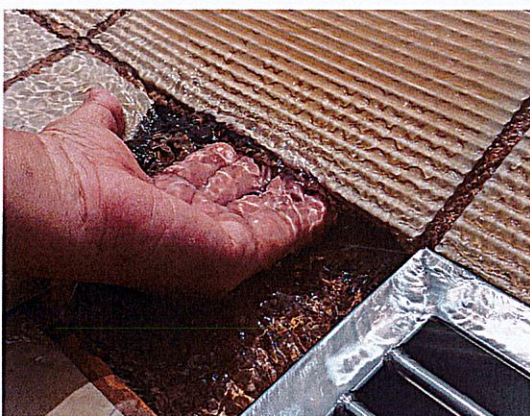
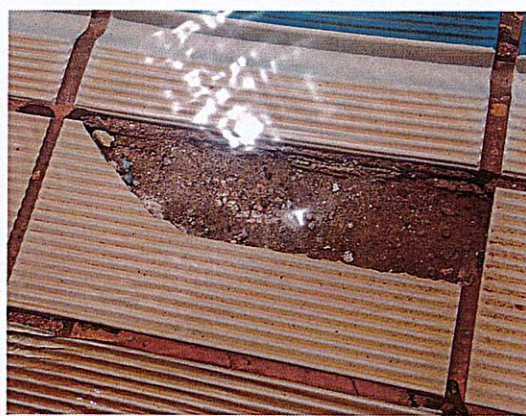
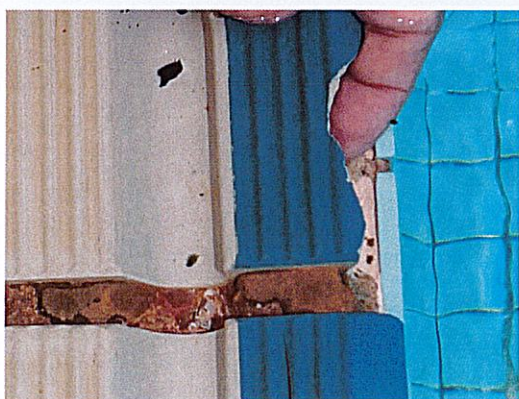
- ❖ Erosion of Perimeter Grout: The grout surrounding the perimeter tiles has worn away significantly.
 - ❖ Cracking of Pool Tiles: Structural integrity is being compromised due to a lack of support and movement in the tile bed.

- ❖ Water Seepage: Water is flowing uncontrollably beneath the tiles via channels where grout has failed, potentially undermining the subsurface structure.

These symptoms indicate ongoing degradation caused by long-term wear, environmental exposure, and inadequate sealing.
- 3) If left unaddressed, the current damage will continue to expand, resulting in:
 - ❖ Detachment of additional tiles
 - ❖ Breaking of additional tiles
 - ❖ Internal water damage to the substructure
 - ❖ Increased maintenance costs in the future
 - ❖ Downtime or partial closure of the pool for emergency repairs
 - ❖ Potential safety risks
- 4) It was recommended that comprehensive preventative maintenance be carried out, including:
 - ❖ Removal and replacement of all eroded perimeter grout with high-durability, water-resistant grout
 - ❖ Removal and replacement of all poolside tiles with homogenous tiles. This will eliminate the ad hoc replacement of tiles of mismatched colours
 - ❖ Carrying out maintenance grouting on the inside of the swimming pool

To carry out comprehensive re-tiling and grouting repairs and associated works at poolside of both the main swimming pool and the wading pool at a total cost of up to RM200,000.00 (Ringgit Malaysia Two Hundred Thousand), and that the Management Committee is authorized to engage a qualified contractor for such works after due process of obtaining three comparative quotes.

- 1) The Management has recommended carrying out repair and maintenance work on the perimeter grouting of the facility's swimming pool. This is to correct a potential safety and operational hazard. Failure to act will inevitably lead to further deterioration and higher repair costs. Immediate remedial action is recommended to prevent the problem from escalating.
